Issaquah Creek Streambank Enhancement

Existing & Proposed Conditions:

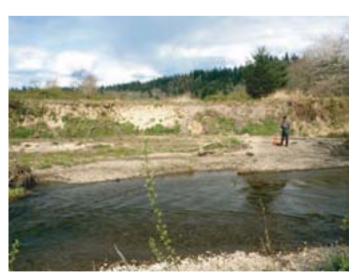
Along the right streambank at this location is a vertical streambank 10-12 feet high and approximately 150 feet long. The vegetation extending landward from the top-of-slope is primarily grass and weeds. In contrast to a number of other possible project locations with somewhat similar vertical banks, the active stream flow here has moved away from the toe, leaving a sandy, gravelly bar. As such, the proposed project treatment is also somewhat different.

High bank along Issaquah Creek

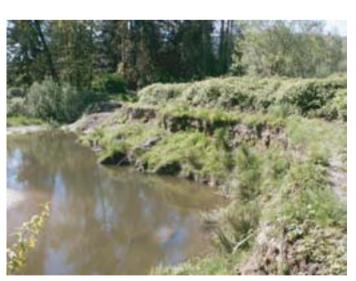
Along the left streambank at this location is a vertical streambank 10-12 feet high and approximately 150 feet long, similar to those described at other locations along the creek in that respect. The vegetation extending landward from the top-of-slope is primarily grass and weeds. In contrast to previous possible project locations with somewhat similar vertical banks, however, groundcover vegetation growing along the lower banks indicates that the bank may be more stable with less active ongoing erosion. Though water still flows past the toe of this bank, small gravel bars have formed and woody debris has accumulated on

Revegetation would stabilize the existing streambank

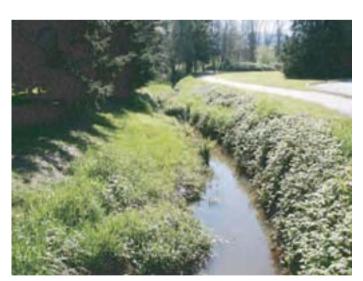
Tibbetts Creek tributary #0170 flows in a straight, ditch-like channel south of the park's offices and maintenance buildings between SE 56th Street and the park entrance road. The tributary joins Tibbetts Creek on the west (downstream) side of the entrance road at the point where Tibbetts turns to the west, away from the road. On parks property, the tributary flows in a straight, excavated channel that dates from the period when the area was cleared and drained for farming early in the last century. Several similar and parallel excavated drainages occur in the park to the northeast. The tributary is low-gradient with a silty channel. It presently lacks woody materials in and along it which would provide habitat cover. Vegetation along its lower section on-site is wanting, consisting almost exclusively of invasive and non-native reed canarygrass and Himalayan blackberries. Farther upstream, on-site vegetation improves, including maturing conifer trees, salmonberry, snowberry, sword fern, and lady fern, however invasive English ivy is also present.

Existing Tibbetts Creek tributary #0170

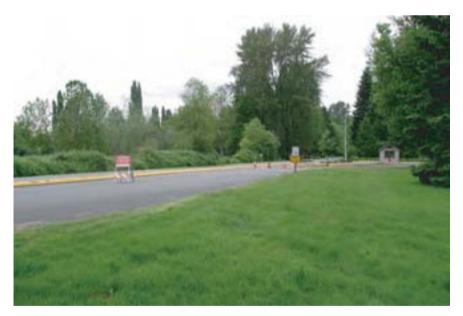
The existing park entry road is adjacent to the east side of Tibbetts Creek and limits the width of the stream buffer in this area. This project would relocate the park entry road further to the east in an area of mostly existing lawn to create a larger and more effective stream buffer along Tibbetts Creek.

Existing entry road precludes buffering to Tibbetts Creek nearby

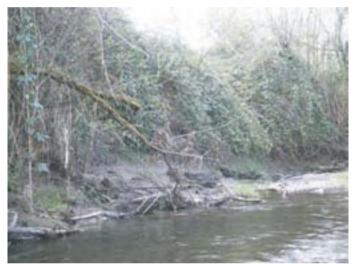
Centrally-located along the portion of Issaquah Creek on-site is a relatively straight and narrow channel section confined by dense black-berry thickets on both sides. This section has comparatively low levels of woody debris and, unlike the channel sections immediately upstream and downstream of it, has relatively little bank erosion.

Existing streambank

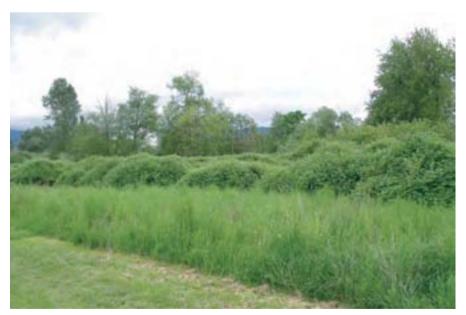
A fairly large bend in the stream at this project location was cut off from active flow when the stream eroded a "short cut," bypassing the bend, some time about a decade ago. This "short cutting" of stream and river channels whereby the flow finds and takes a shorter route instead of its previous meandering, circuitous route is known as avulsion. The cut-off channel section which no longer carries active stream flow is called an oxbow. The area of the oxbow is presently very brushy, including dense Himalayan blackberry thickets, making it fairly inaccessible.

Streambank along the oxbow

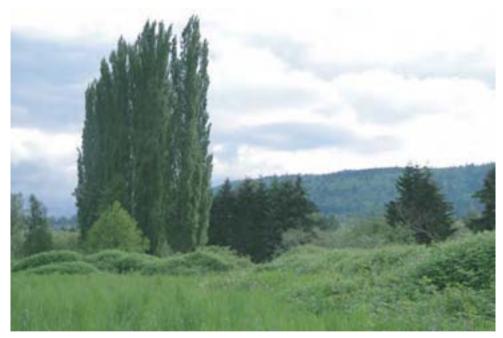
As such, it is likely that the best location for an additional footbridge crossing of Issaquah Creek would occur somewhere along this section. One area of interest is just downstream of a row of existing poplar trees. This location is fairly close to either alternative for a "creek play" area (projects C1 and C2), and is an opportunity for a relatively short-span bridge due to a fairly deep, stable stream channel with steep sides.

Possible site for an additional footbridge
